Final Five-Year Review Report

**IR Site 1: Old Base Landfill
IR Site 2: Fire Training Area
Former Naval Training Center – Bainbridge
Port Deposit, Maryland**

Contract N40080-12-D-0451
Task Order 0007

June 2016

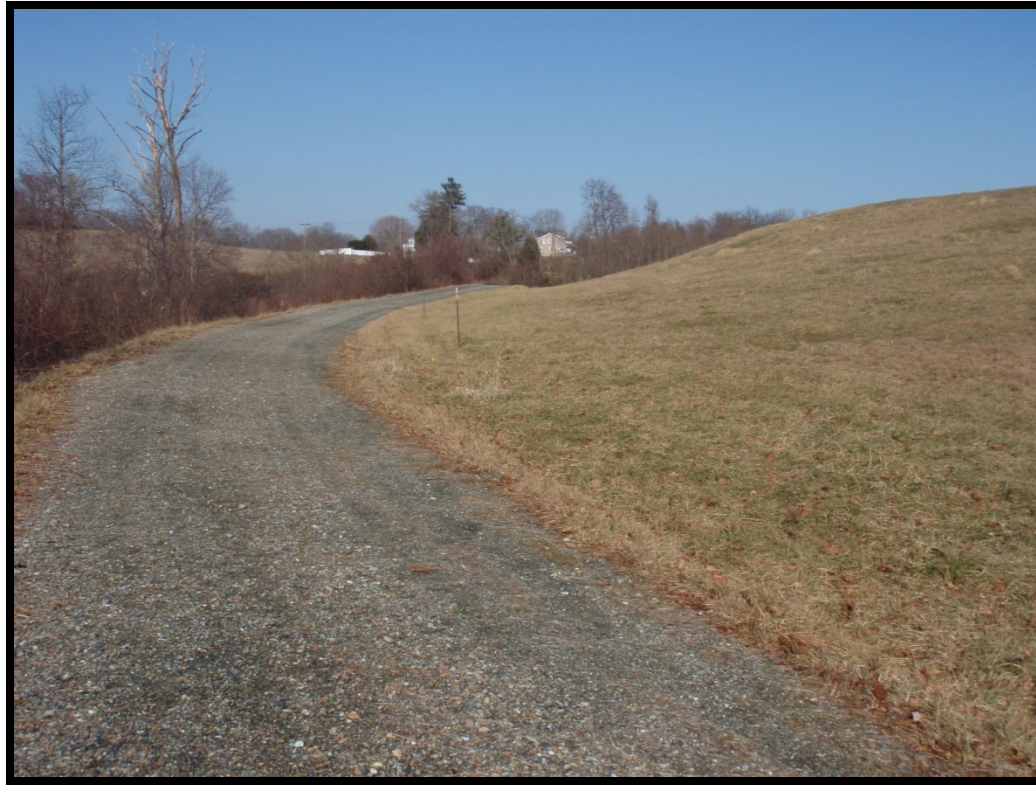
OBL Photograph 3

View of Site 1 road and slope, facing northwest. Road was in good condition.

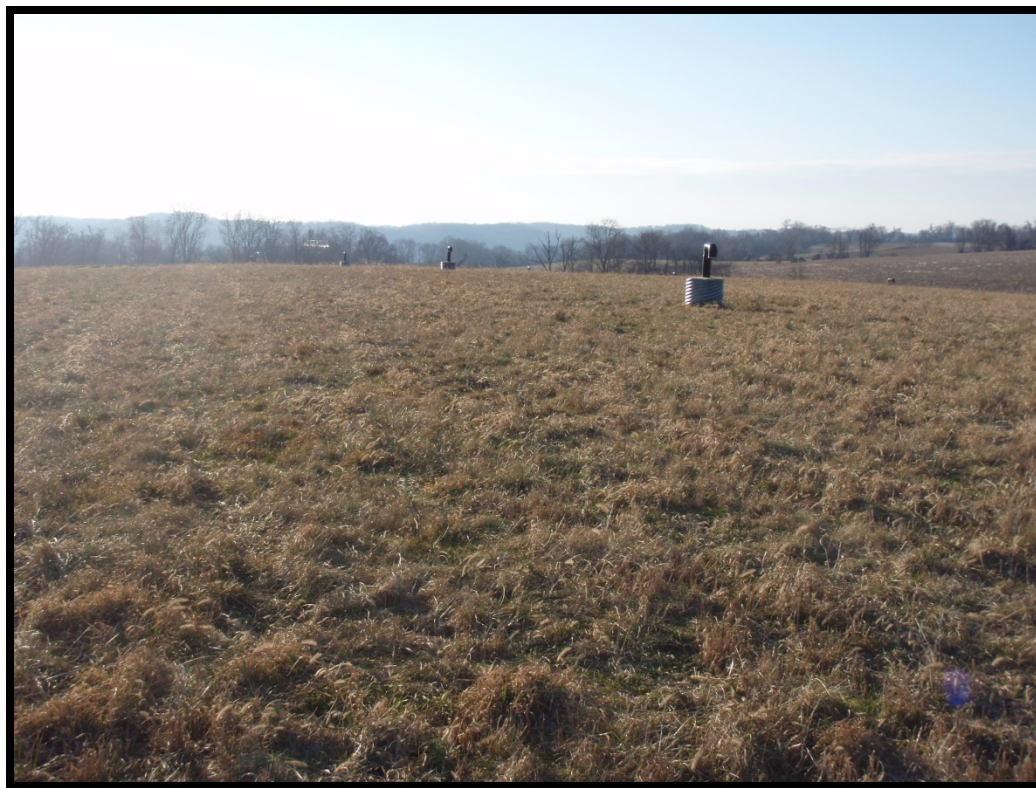
OBL Photograph 4

The landfill cap appeared to be in good condition and there were no signs of erosion, cracks, settlement, pooling water, or seeps. The vegetative cover appeared to be in good condition and had just recently been mowed. The concrete reinforced gas vents were observed to be in good condition.

General view of Site 1 cap and vents, facing west. Vents were replaced in 2007.

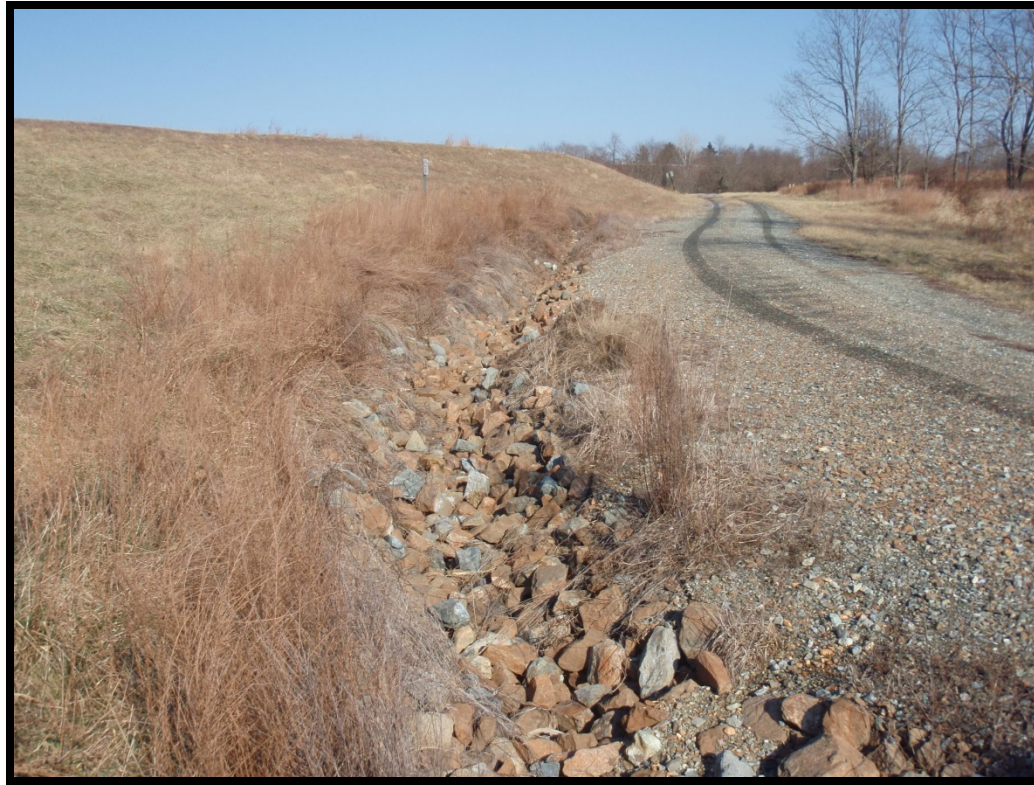
OBL Photograph 5

View of Site 1 rip-rapped channel along southern edge. Channel is shown free of debris and appears to be effective.

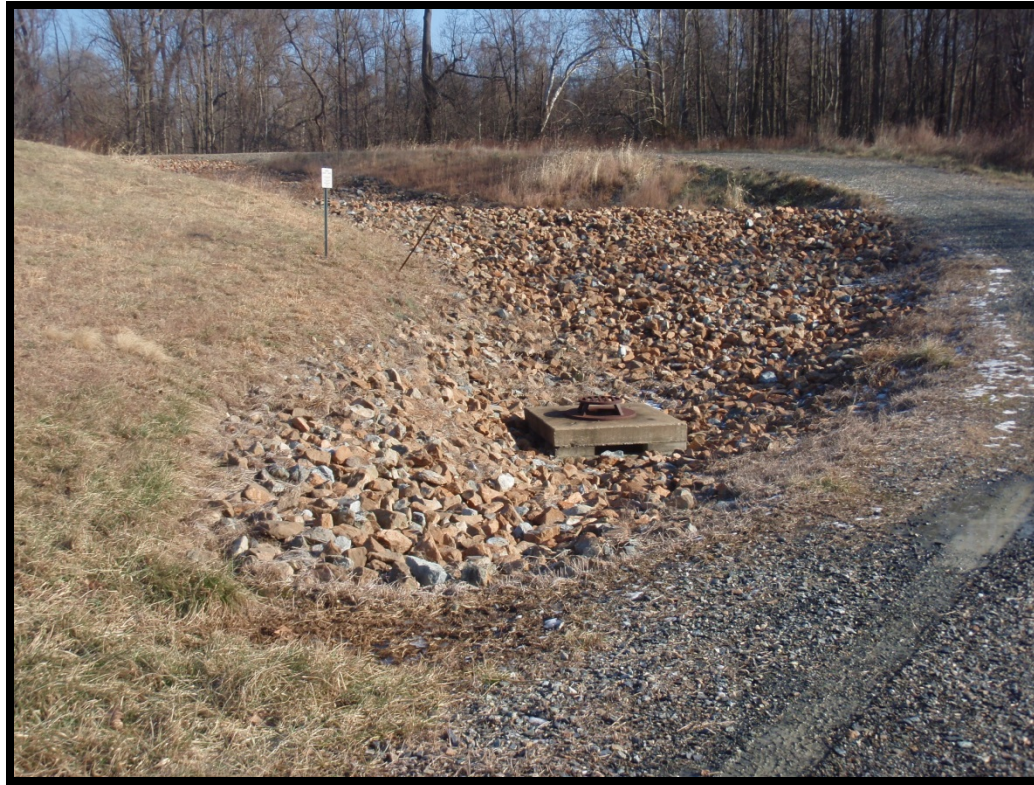
OBL Photograph 6

View of Site 1 rip-rapped letdown channel along southern edge. Channel is shown free of debris and appears to be effective.

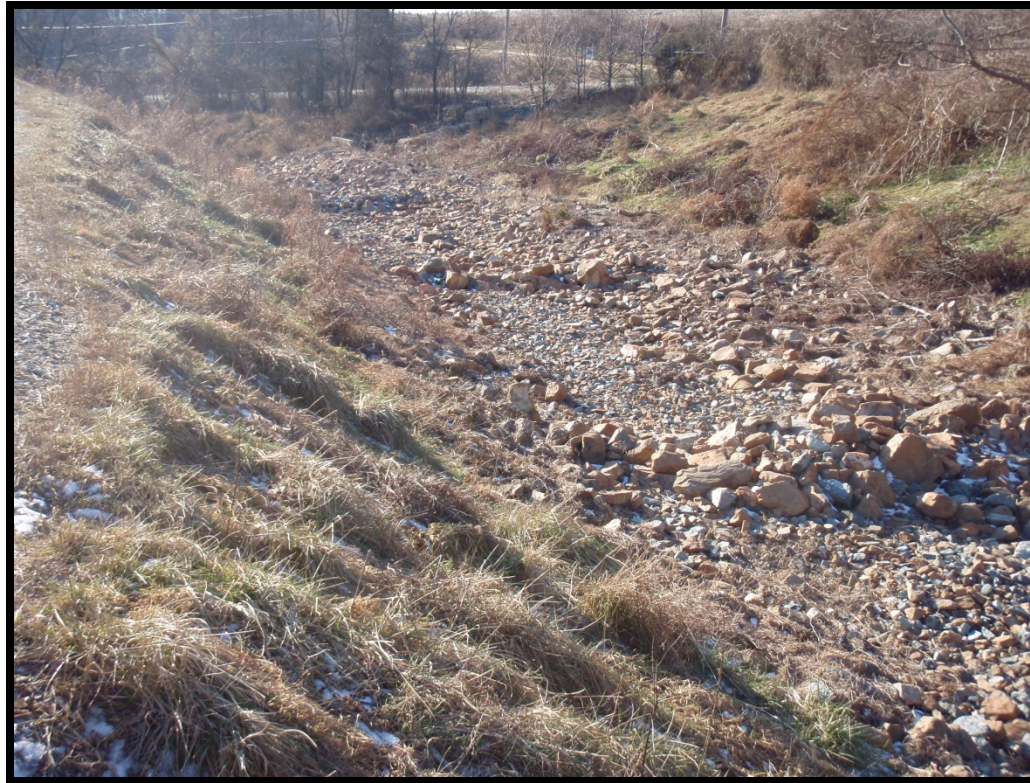
OBL Photograph 7

View of rip-rapped channel along western end of Site 1. Channel is shown free of debris and appears to be effective.

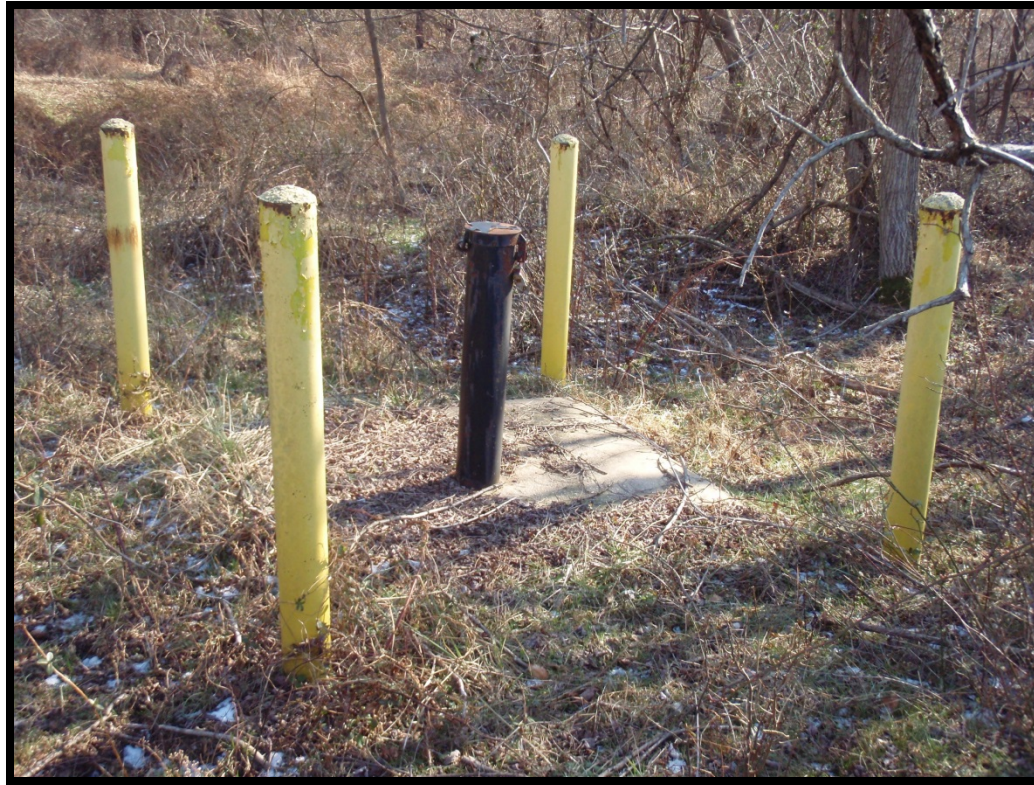
OBL Photograph 9

All monitoring wells and gas probes were accounted for and observed to be in relatively good condition; however, general maintenance issues were associated with a majority of the locations. Almost all monitoring well and gas probe locks were difficult to open or were missing and were subsequently replaced by BDC.

View of typical Site 1 gas probe/monitoring point. Several had malfunctioning locks or were missing locks.

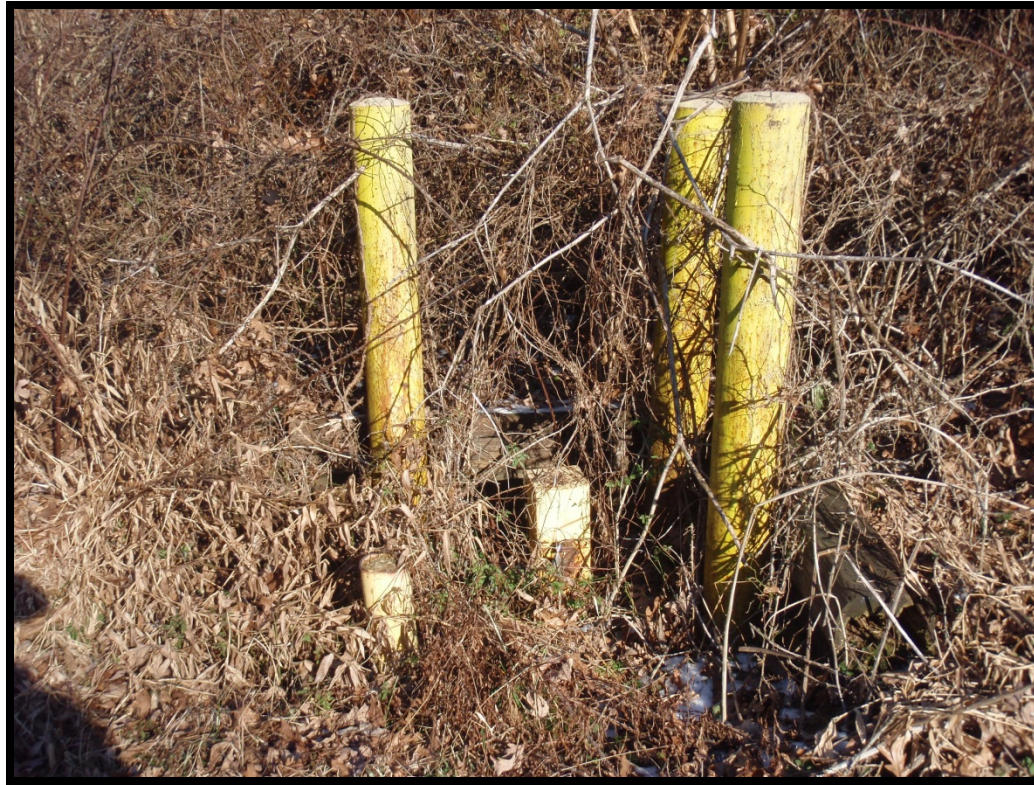
OBL Photograph 11

View of typical Site 1 monitoring wells located onsite. Several had malfunctioning locks that will need removed and replaced.

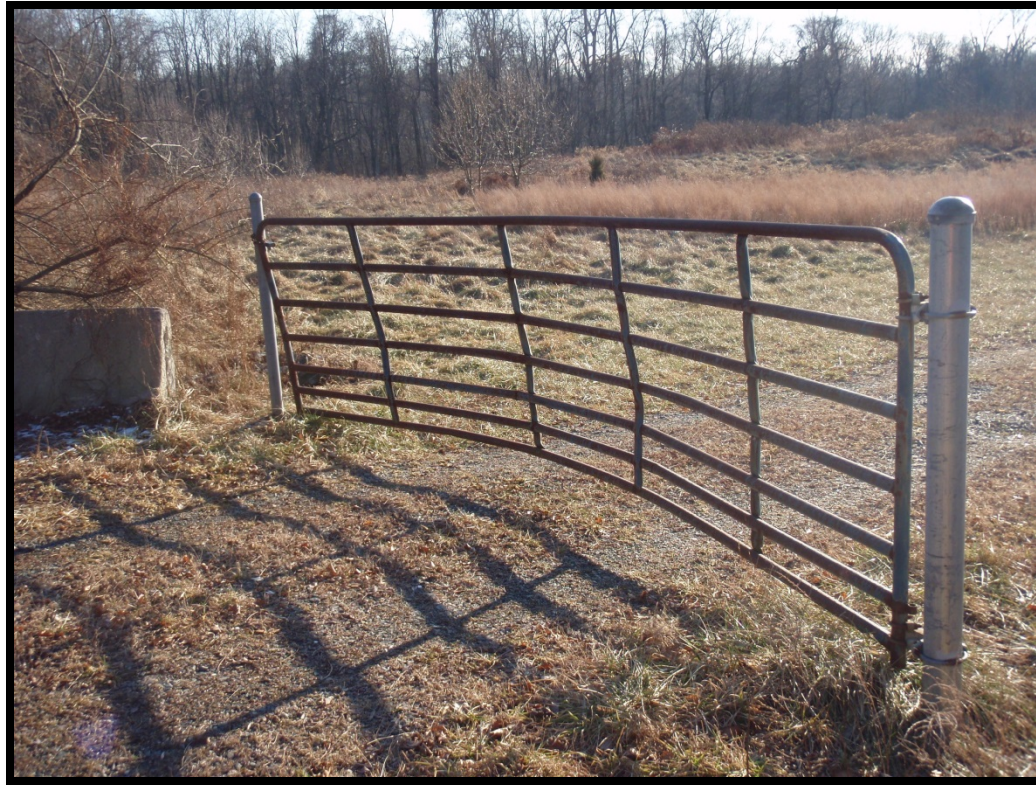
OBL Photograph 12

View of Site 1 entrance gate. Gate is damaged, but functional.

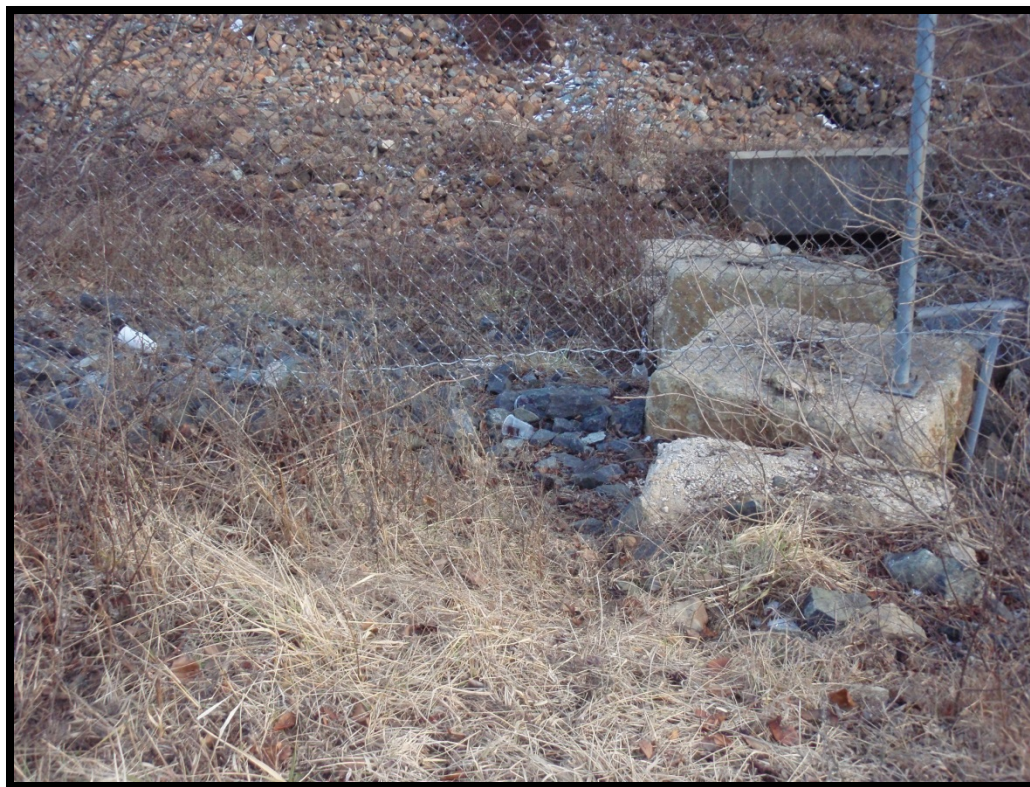
OBL Photograph 13

View of perimeter boundary fence along Maryland Route 276. Note gap underneath fence big enough for a person.

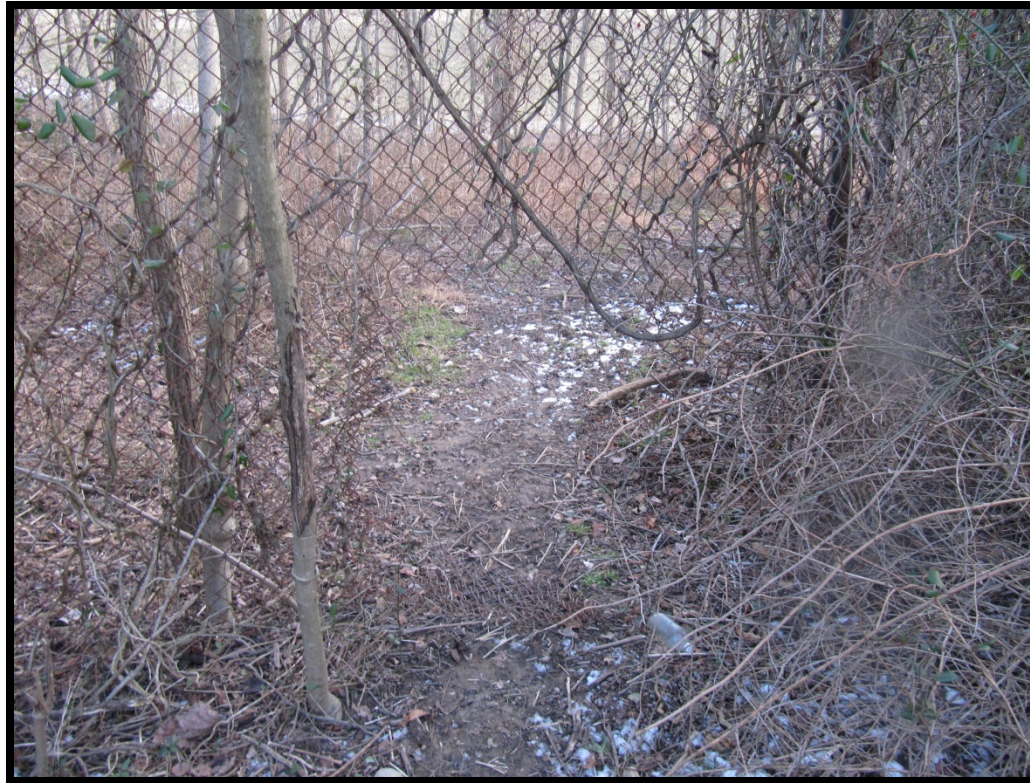
OBL Photograph 13

The chain link fence that surrounds the perimeter of the site was inspected and observed to be in good condition, with the exception of an opening in the fence near GP-14. Just inside the fence, two areas of soil erosion were observed extending from the berm of Route 276 to the down-gradient rip-rap drainage channel. Both erosion areas were observed along Route 276, near gas probe GP-14. These issues were reported to BDC and repaired in late 2015.

View of hole in perimeter boundary fence along Maryland Route 276. This is located north of the gate and near to GP14.

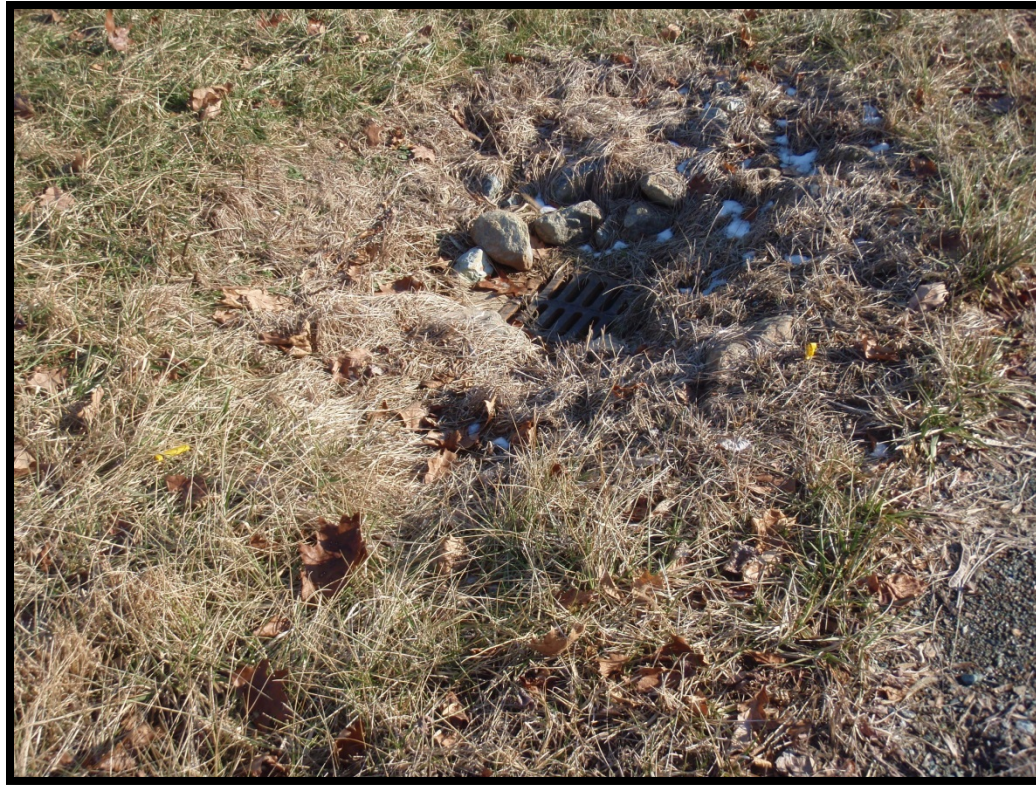
OBL Photograph 14

View of Site 1 drain grate partially covered with vegetation.

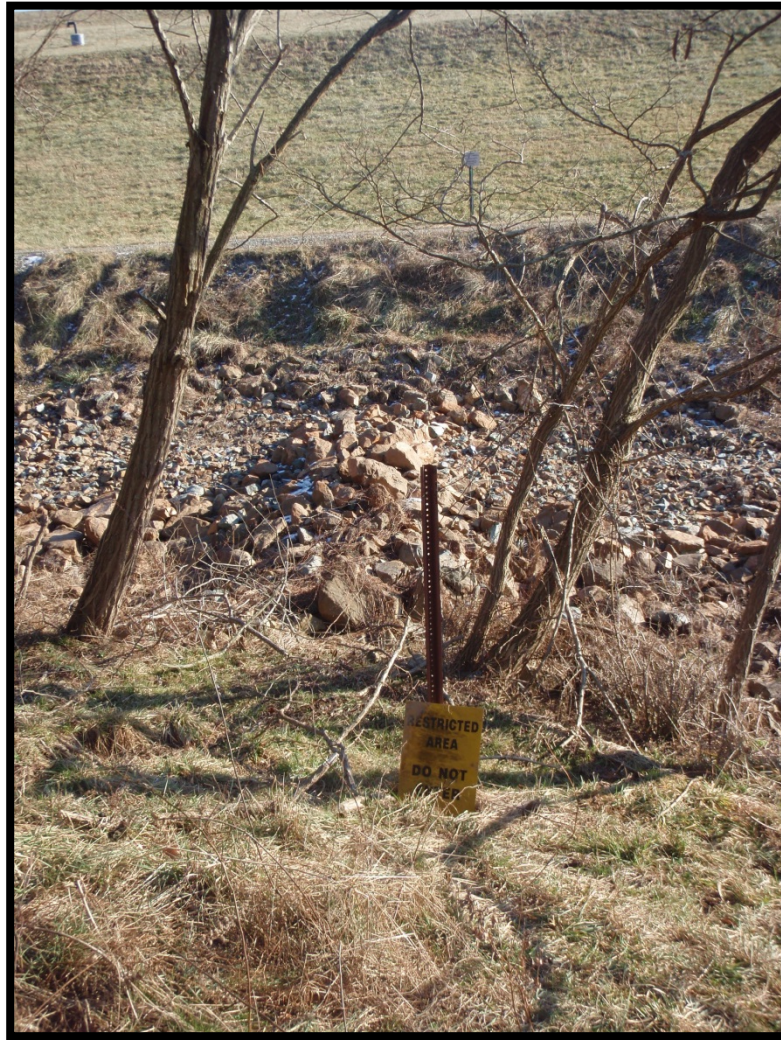
OBL Photograph 15

View of Site 1 facing east from Maryland Route 276 near GP14. Sign needs repaired.

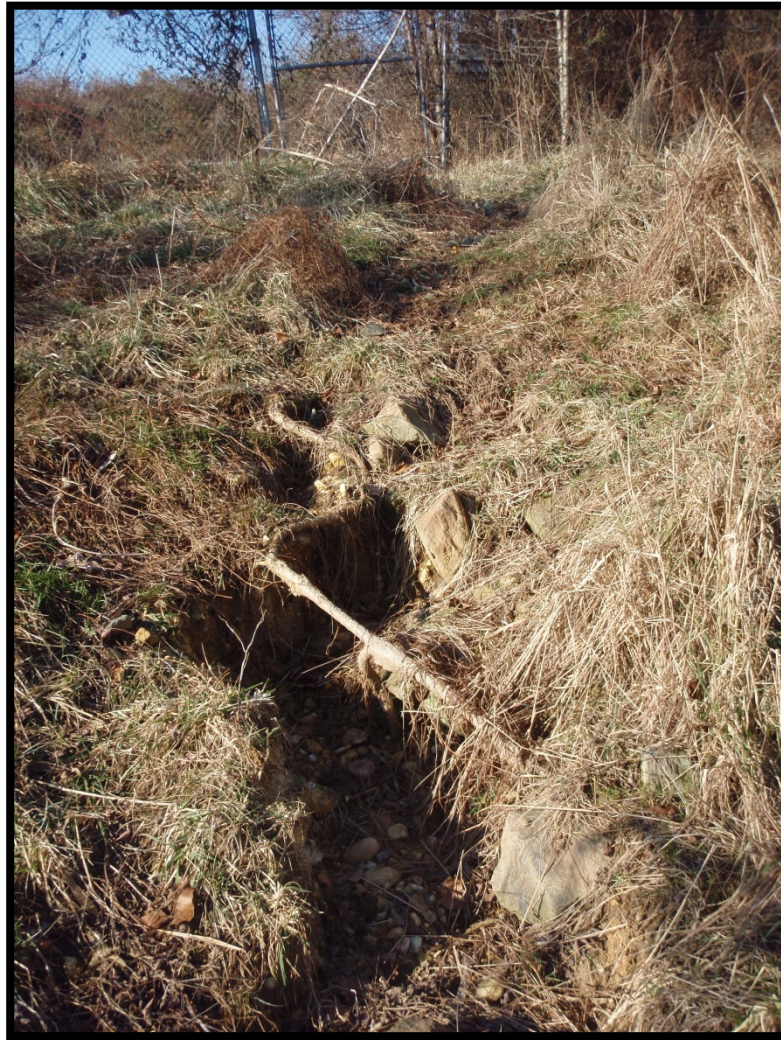
OBL Photograph 16

View of erosion near Maryland Route 276 and near GP14. Note, this is erosion is not impacting Site 1.

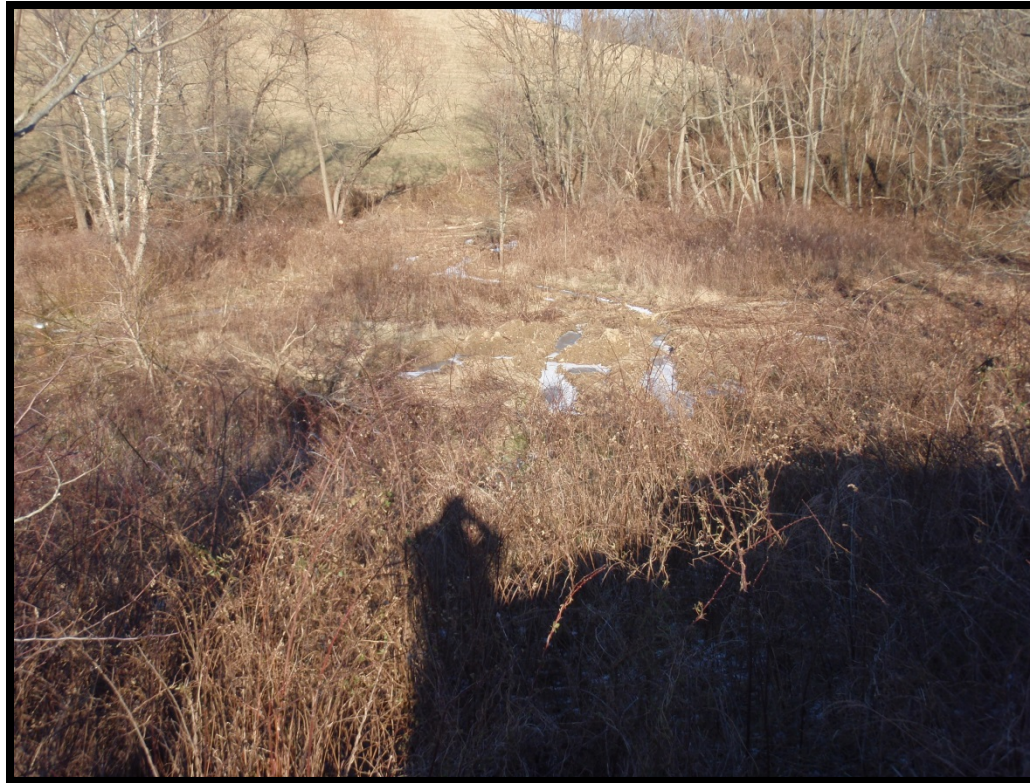
OBL Photograph 17

A recently rutted section was observed in the area between OBL and the Rubble Landfill. There was no explanation given for the ruts, and they appeared to be outside the OBL boundary.

View of area between Site 1 and the adjacent Rubble Landfill. Note the ruts in the area.

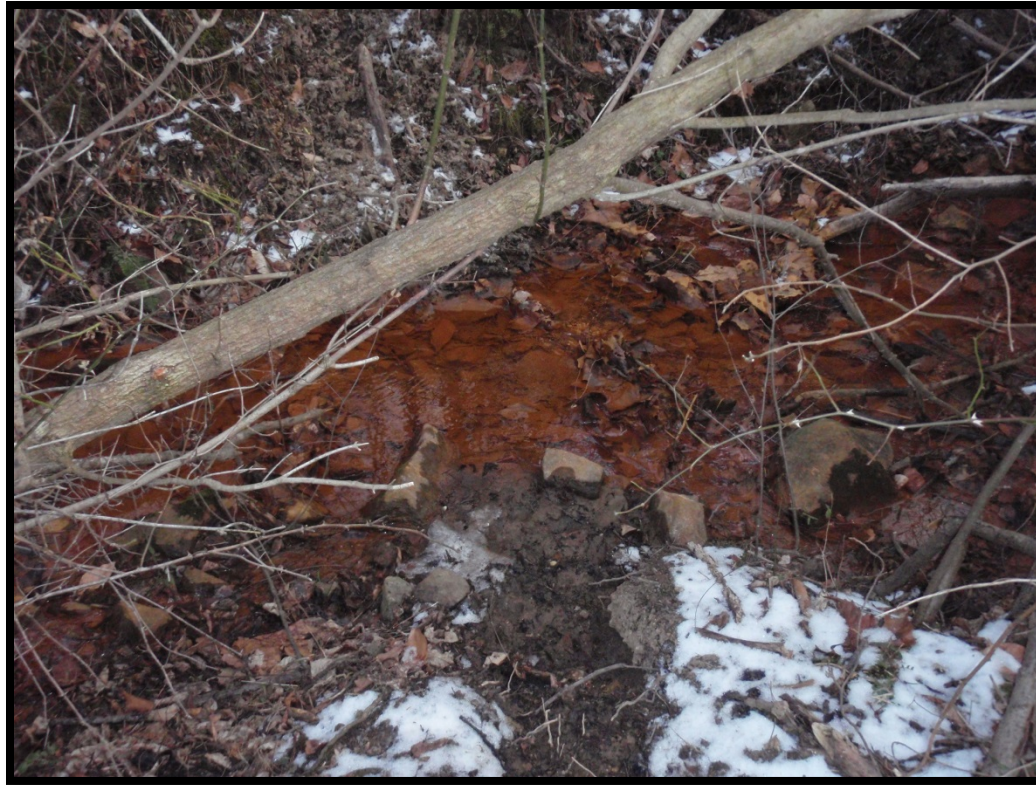
OBL Photograph 18

Orange staining of rocks and stream sediments was observed in the down-gradient drainage channel along Route 276, beginning at the southern end of the rip-rap section next to gas probe GP-12. The staining was observed downstream to a point next to gas probe GP-11. The stream was observed to be normal in appearance (no orange staining) at the point near the water tank entrance and monitoring wells 1-GW-10 and 1-GW-7. The cause of the visible staining is suspected to be from iron leaching from the rock in the rock-lined channel.

View of the stream adjacent to Maryland Route 276. Note the red staining that has been historically documented. This staining is suspected to be a result of the rip-rap used at the site weathering.

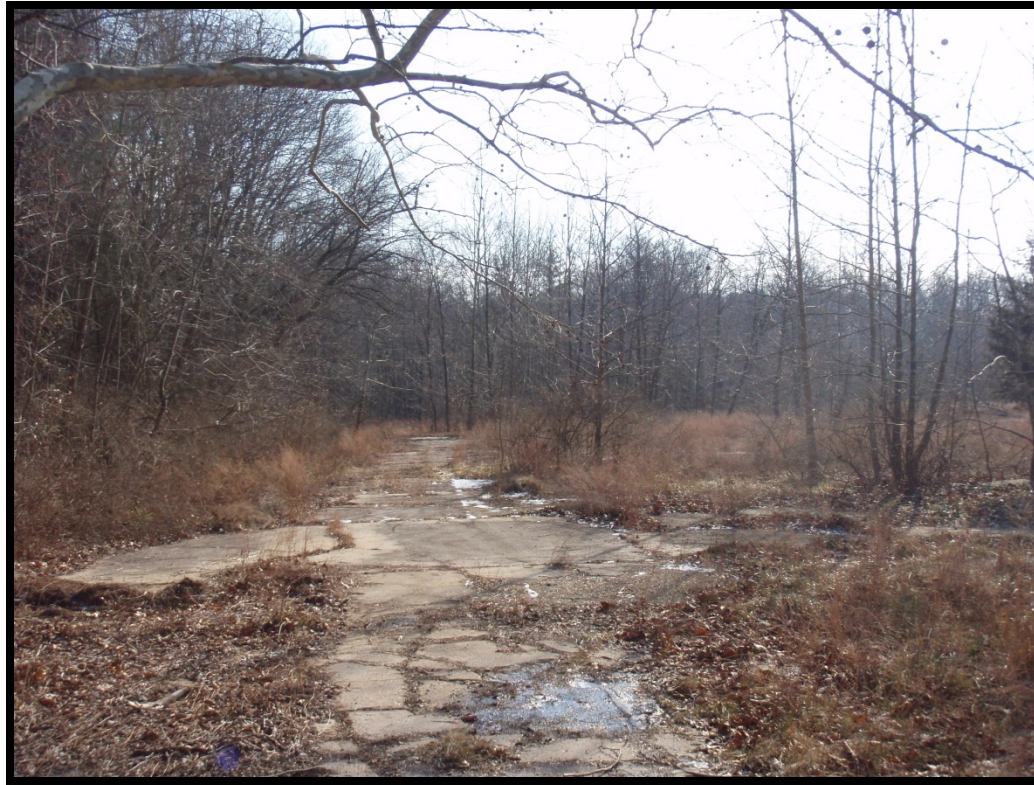
FTA Photograph 1

West facing view of the concrete pad associated with the former FTA. Substantial vegetation was observed growing through cracks in the concrete.

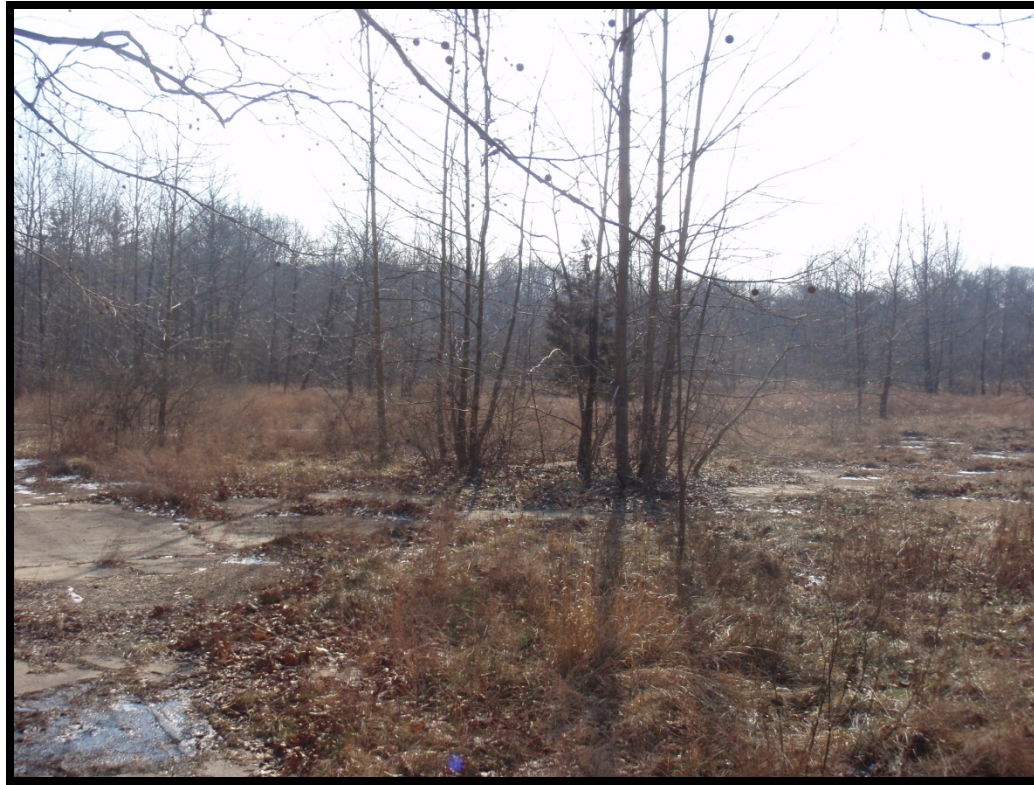
FTA Photograph 2

West-southwest facing view of the concrete pad associated with the former FTA. Substantial vegetation was observed growing through cracks in the concrete.

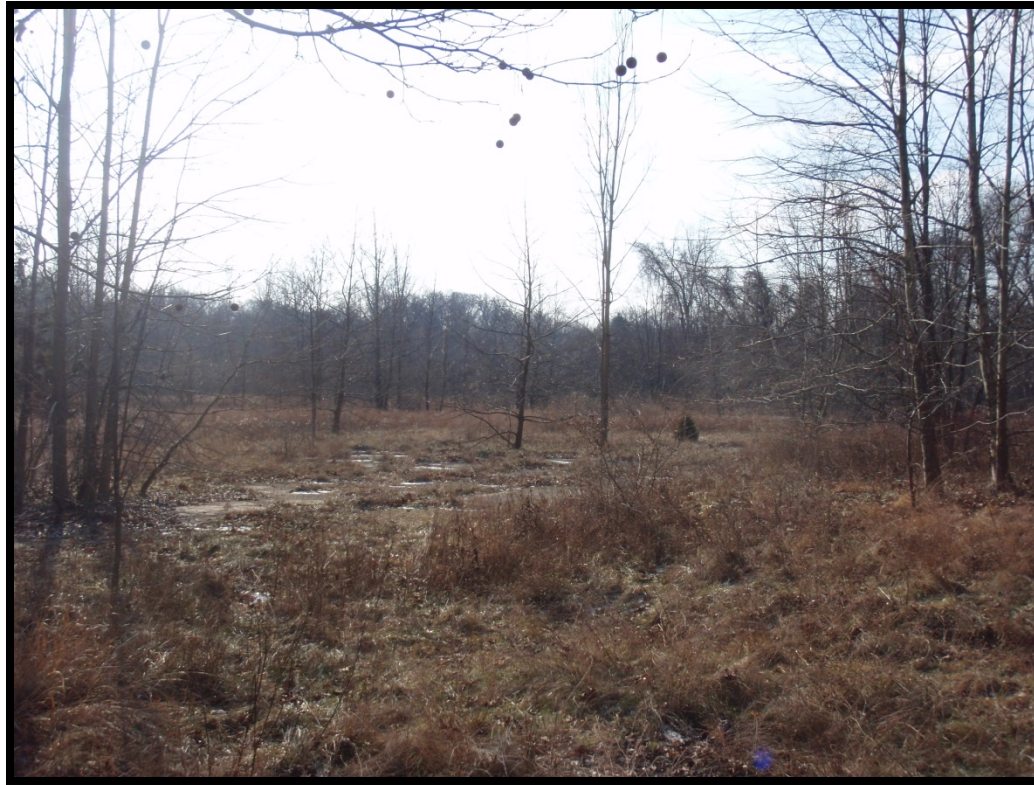
FTA Photograph 3

Southwest facing view of the concrete pad associated with the former FTA. Substantial vegetation was observed growing through cracks in the concrete.

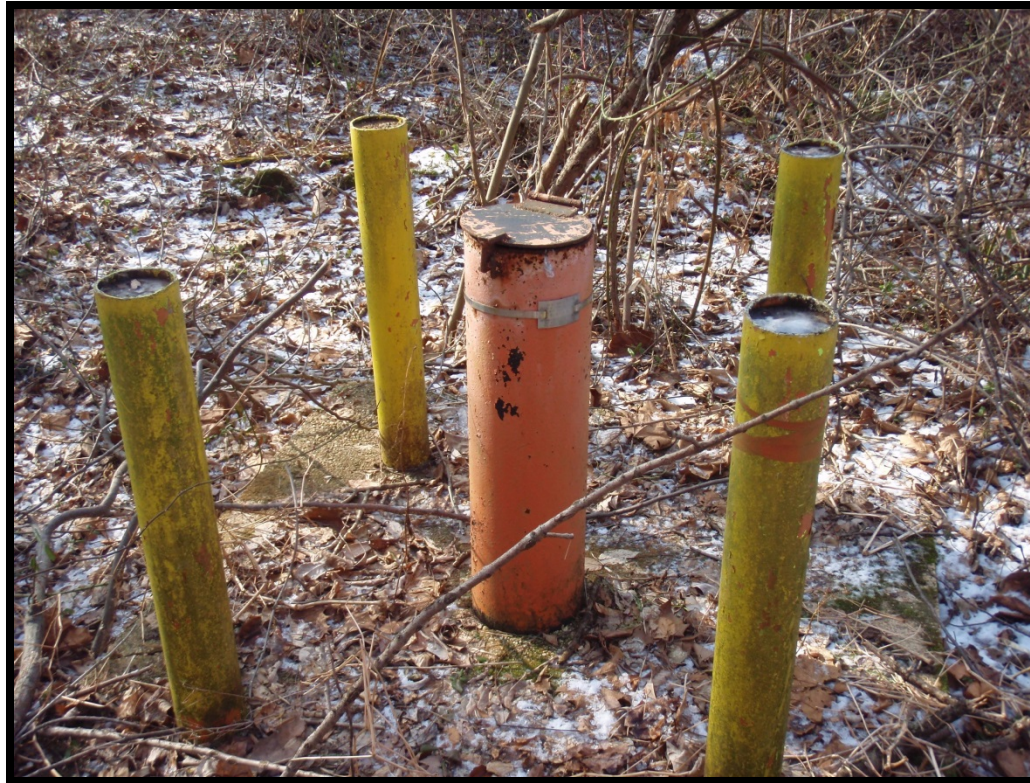
FTA Photograph 4

Monitoring well 2-GW-2 associated with the former FTA. Both monitoring wells were unlocked and need well caps replaced; however, there was no sign of vandalism.

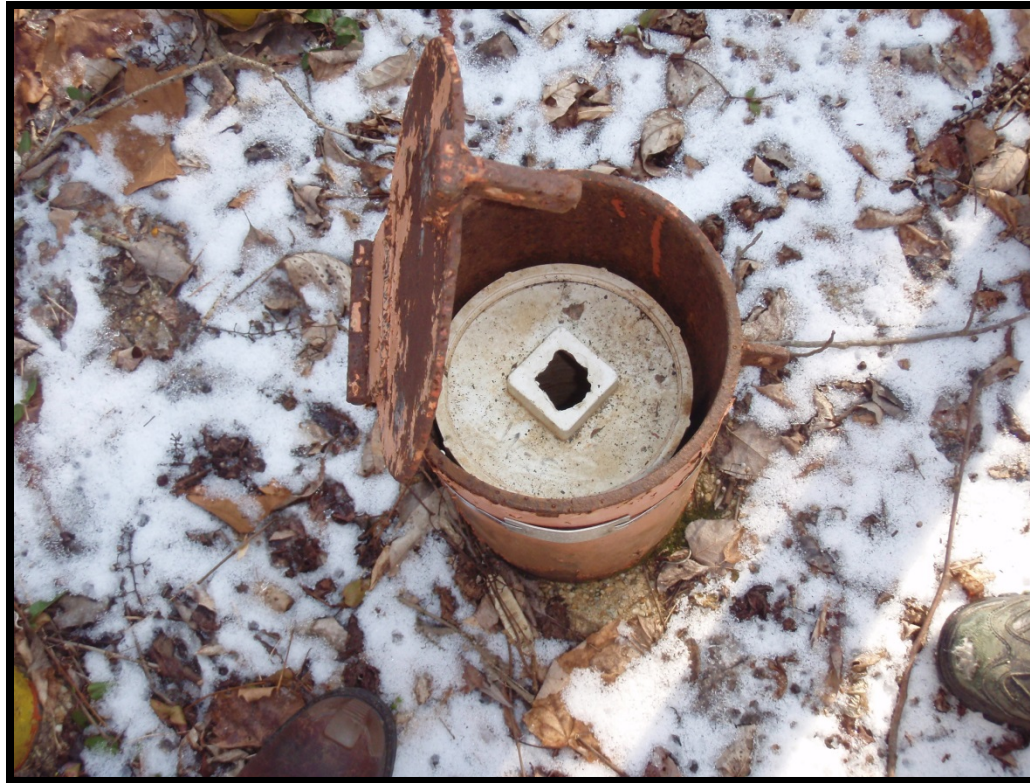
FTA Photograph 5

Monitoring well associated with the former FTA showing compromised well cap.

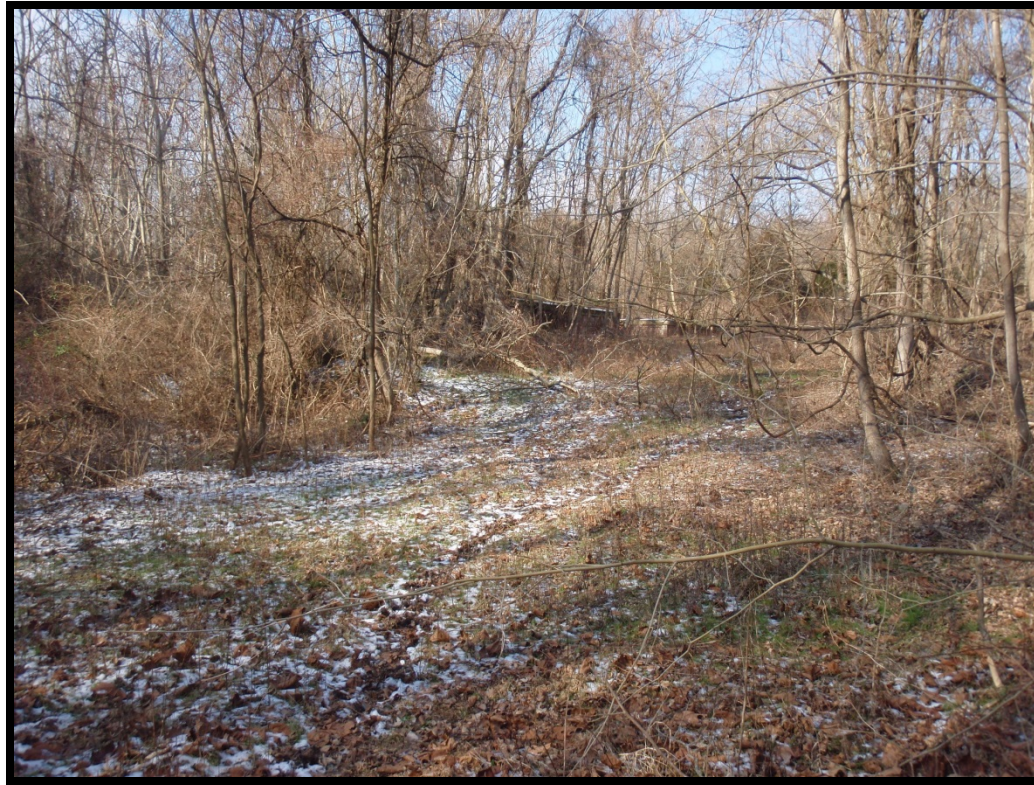
FTA Photograph 9

Northwest facing view of the former FTA. Substantial vegetation was observed at the site, and may impede access to monitoring wells if not controlled.
